A CRASHWORTHY ARMORED PILOT SEAT
FOR HELICOPTERS

Bernard Mazelsky

Naval Air Development Center

4. TITLE (and Subtitle) A CRASH WORTHY ARMORED PILOT SEAT FOR HELICOPTERS		5. TYPE OF REPORT & PERIOD COVERED Final Report
7. AUTHOR(s) Bernard Mazelsky ARA, Inc., W. Covina, Calif. 91790		6. PERFORMING ORG. REPORT NUMBER USAAVSCOM TR 73-34 ✓

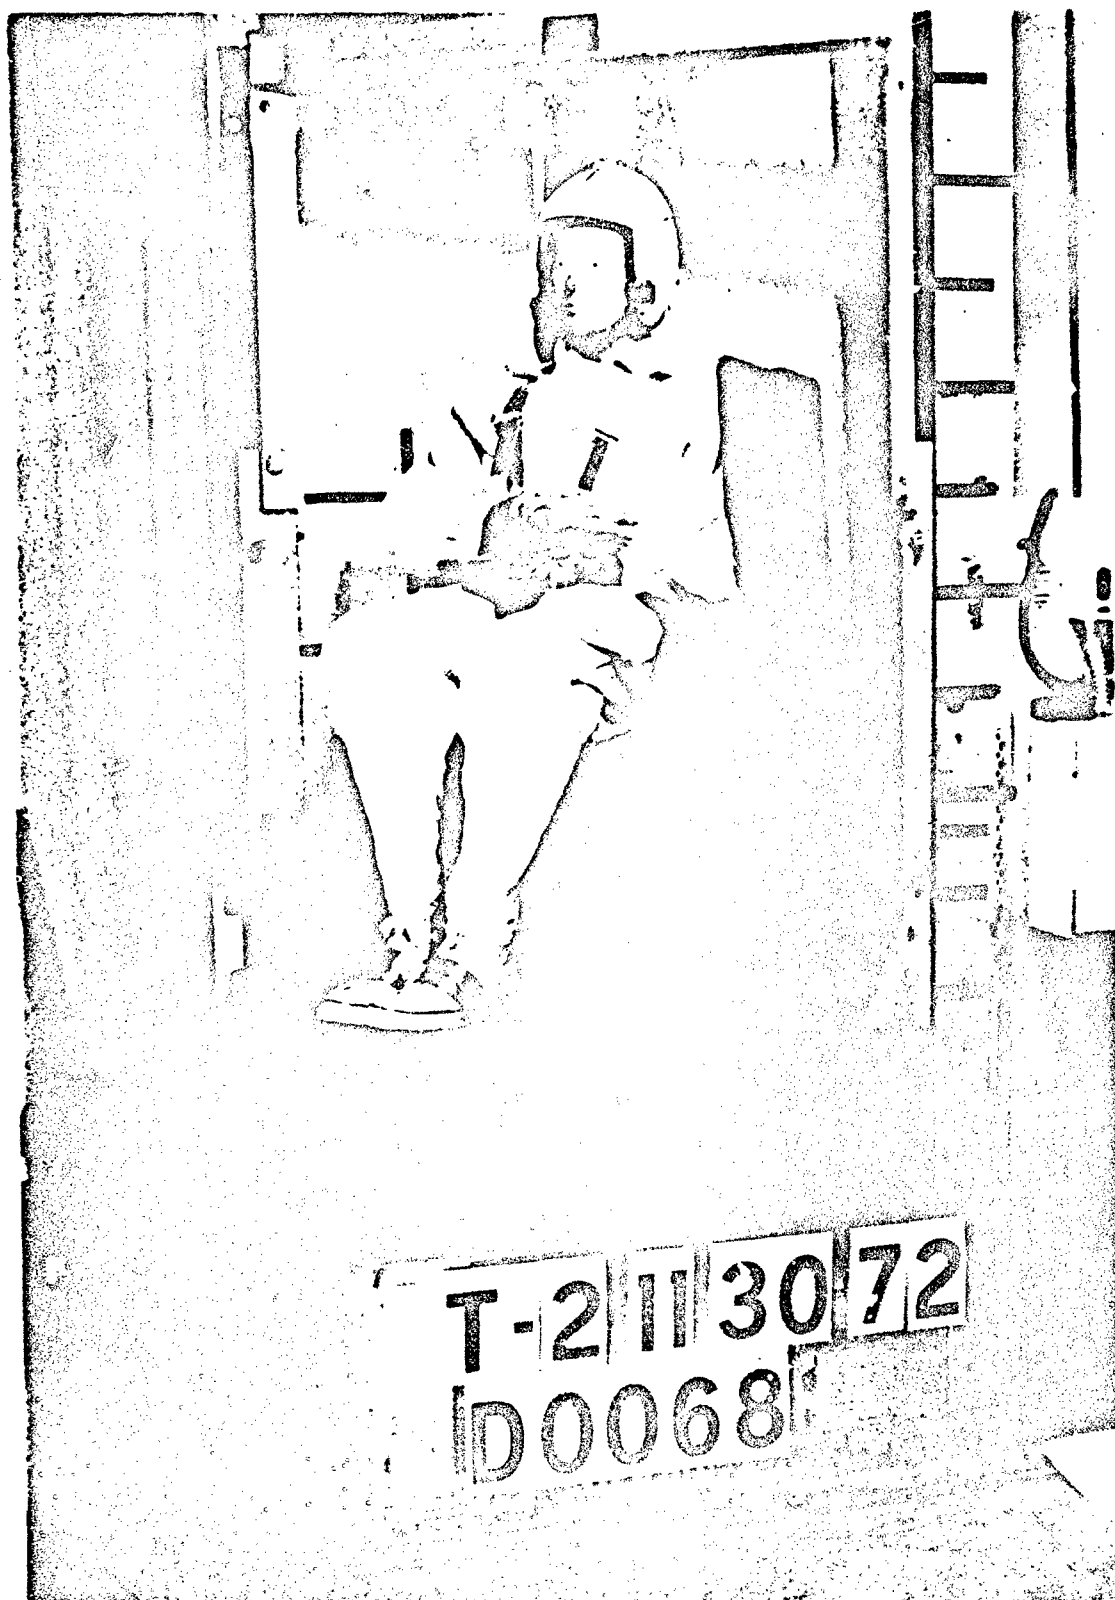
Figure 15. Position of Seat and Dummy for
ARA Drop Test

A photograph showing the position of the seat and dummy prior to a drop tower test is given in Figure 15. A 95th percentile male dummy was placed in the seat and the seat was then positioned in its rearmost horizontal location and its uppermost vertical location. The uppermost vertical location was chosen as it results in the maximum loads applied to the seat frame during an impact. All E/A lengths and the seat's location relative to the floor and frame were measured. The drop platform was then raised to the desired height and released. The G load on the seat frame was controlled by four large E/A's positioned at the bottom of the drop tower. After the impact, the lengths of all E/A's and the relative position of the seat were again measured. The difference between the initial and final positions is the motion of the seat.

of the seat in tests 1A and 1B are different because their initial positions are different. The structural integrity was maintained during the two drops. No simple structural failure was detected. The 4-way seating adjustment functioned properly after the tests.

During the drop tower tests a modification to the upper TOR-SHOKs were required in order to prevent the seat from bottoming out on the deck. The modification consisted of placing "stop" rings on the outer and inner tubes of the TOR-SHOKs. With this arrangement the upper TOR-SHOKs could not break loose as was evidenced during Test 1 and Test 2 on the drop tower. Once the rings were installed, the two drop tower tests were repeated and the seat operated properly.

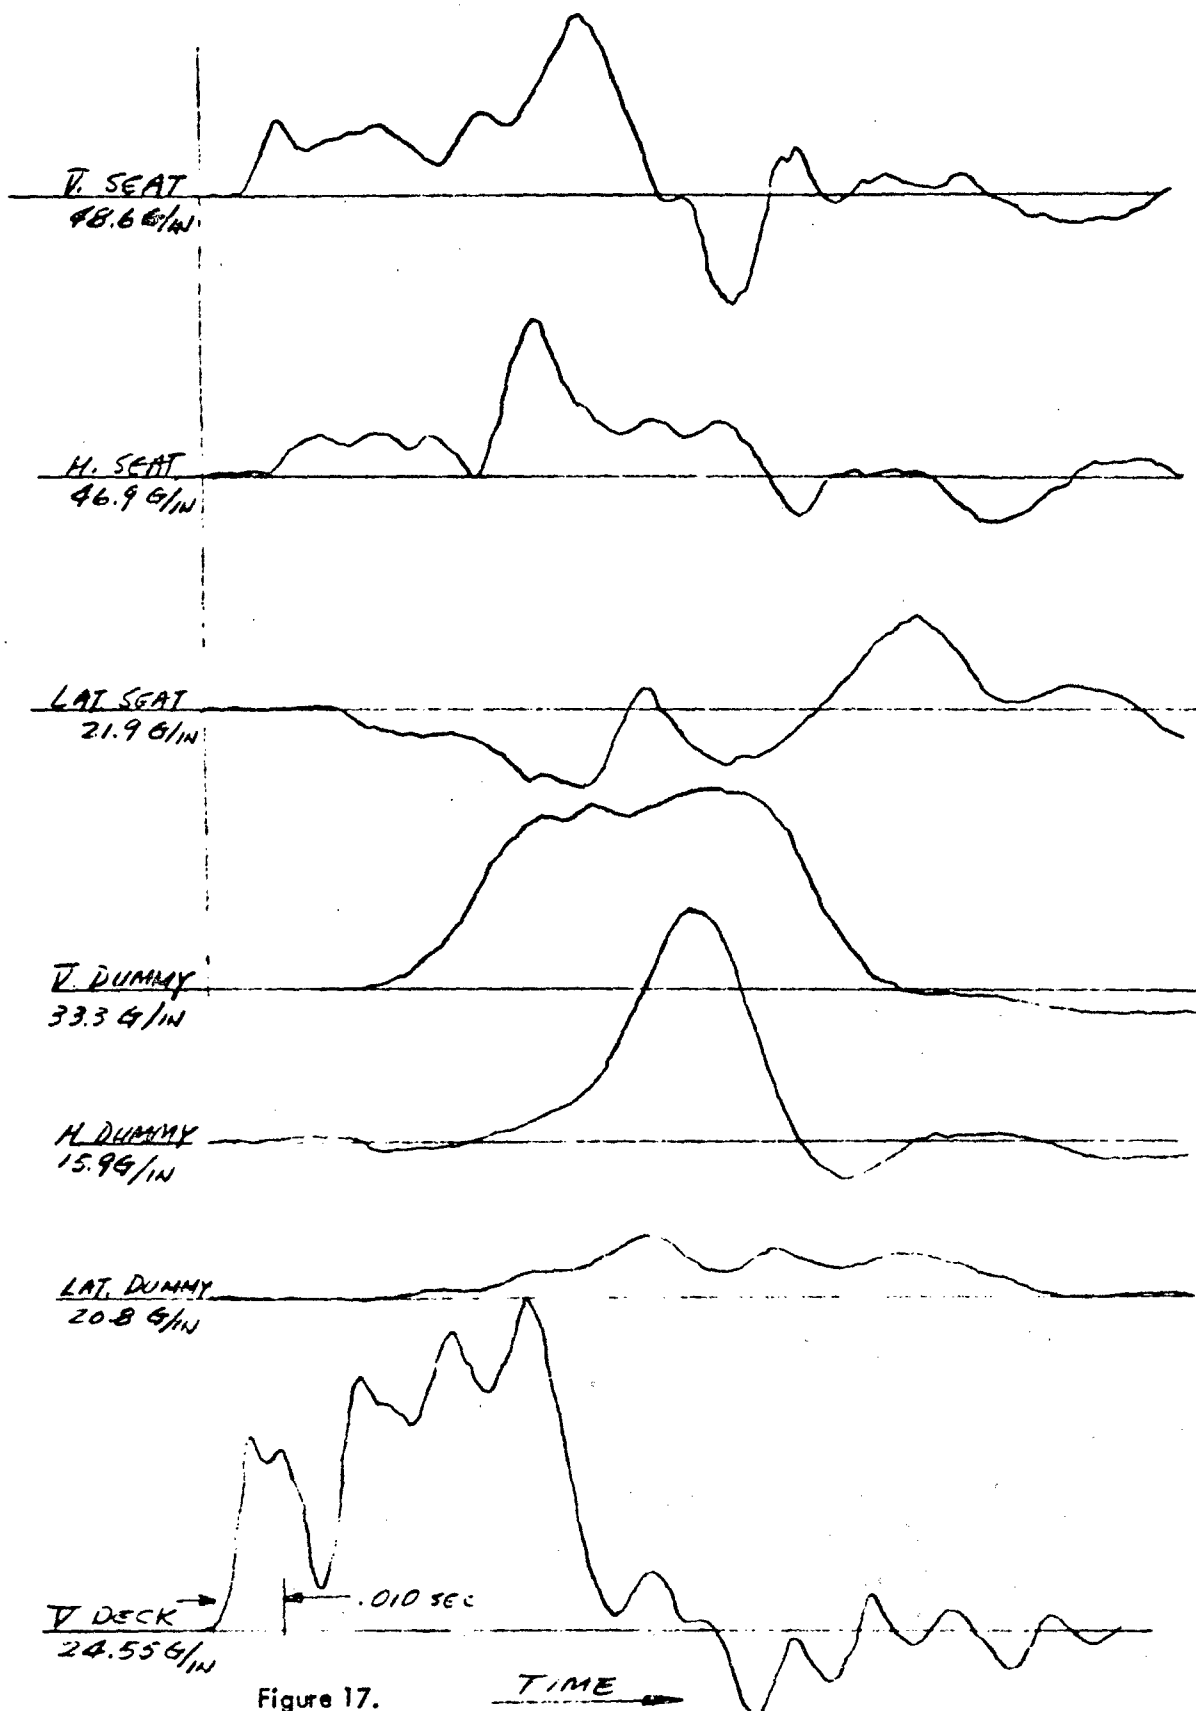
Figure 17.

ACCELERATION RECORD - TEST #1A
COMBINED ANGLE DROP TEST

elements which further increases the force level in the upper TOR-SHOKs. These two combined effects cause the "bottoming out" effect shown in the vertical seat pan deceleration curve of Figure 17 (first curve). The increase in the force level of the top TOR-SHOKs when the wire is sliding is shown in Figure 16. Also shown in this figure is the relative constant values of the middle TOR-SHOKs which do not experience any appreciable wire sliding. For this impact condition, the bottom TOR-SHOKs do not experience any appreciable stroking and consequently were not instrumented. The bottom TOR-SHOKs do stroke when large lateral accelerations are experienced by the seat pan.

The vertical dummy decelerations are largely dictated by not only the vertical seat pan decelerations but in addition, by the elasticity in the restraint system. Unfortunately the dummy experiences no vertical deceleration until half of the impulse deceleration duration was been experienced (See Figure 17, fourth curve). This characteristic means that the elasticity of the restraint system provides no restraint initially, but then the restraint system "catches up" with the dummy, resulting in high vertical deceleration loads. This situation can be alleviated by relocating the inertia reel to the top of the armored bucket (which reduces the length of shoulder harness webbing and consequently the stretch of the webbing), as well as by reducing the stretch of the shoulder harness restraint by stiffer and/or wider webbing. When these modifications are made in the restraint system, further improvements in the dummy vertical deceleration will be obtained.

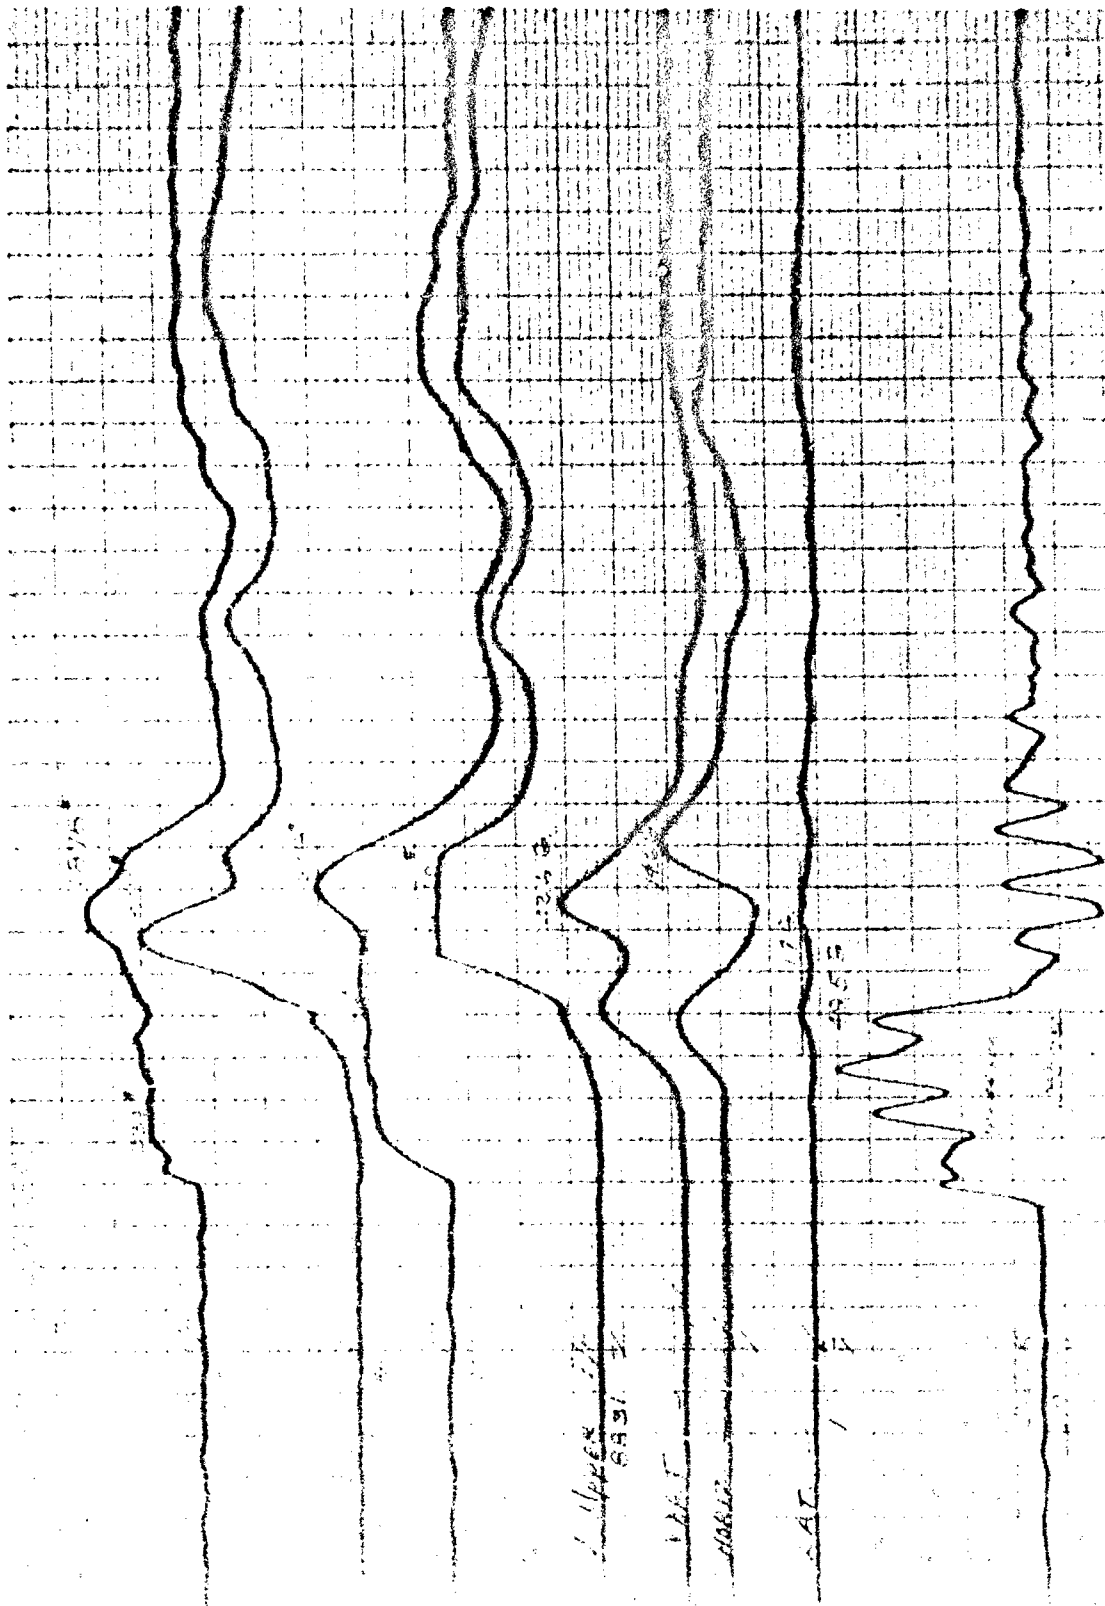
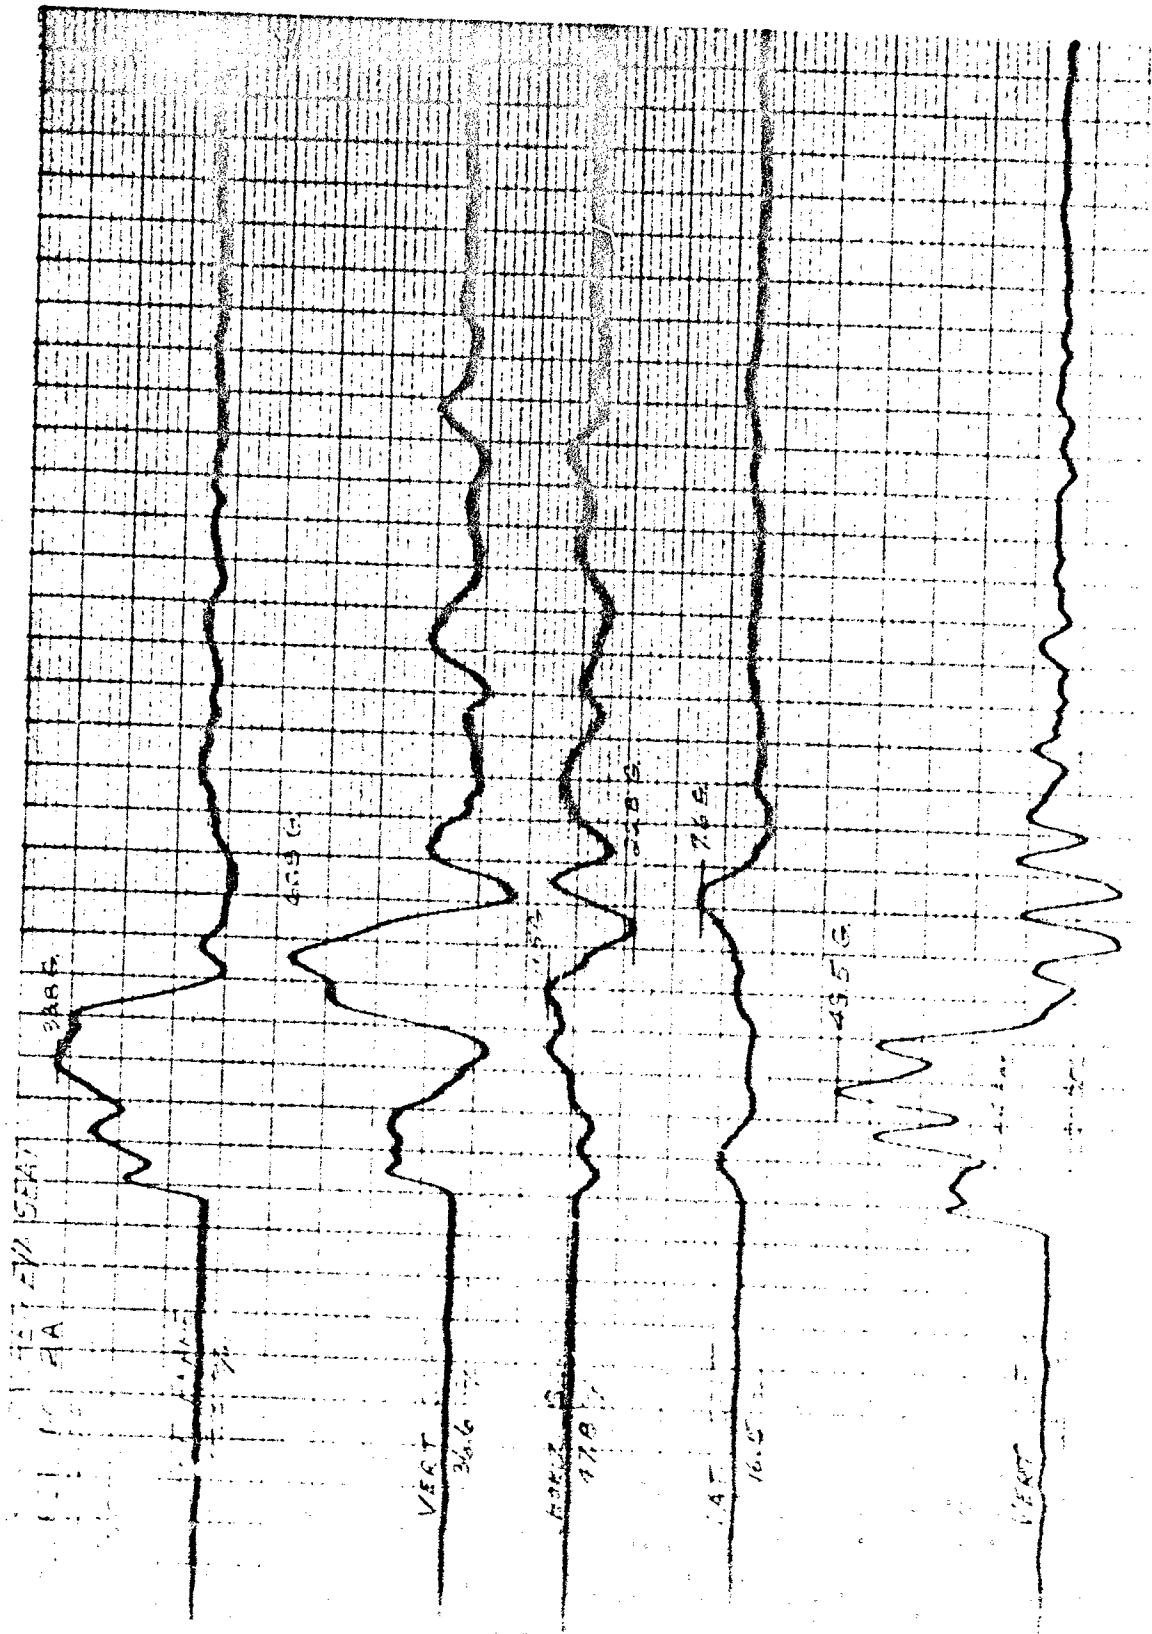
Figure 23. Vertical Drop Tower Test 2 A

"Inspection of the seat after the test showed it to be intact and firmly attached to the floor track. No portion of the seat contacted floor structure and the dummy was restrained by the shoulder and lap belt. Measured downward deflection of the seat was 7-9/16 inch on the right side and 8-1/2 inch on the left side. Because of the large vertical displacement resulting from this test condition, the top TOR-SHOKs made contact with the middle TOR-SHOKs during seat stroke and were indented. It was concluded that the seat functioned within the design specifications and withstood the vertical crash pulse, Figure 23."
